Newsletter Human Factors recurrent training – April 2016

A B206B3 helicopter was hovering at low altitude carrying out an aerial work mission (jet washing high voltage power line insulators) in Taiwan when the engine lost power. The pilot managed to make a forced landing. The aircraft was substantially damaged and both the pilot and mission operator survived with minor injuries only.

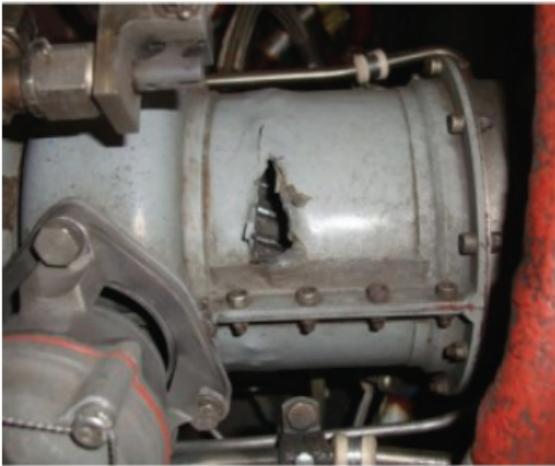
The Taiwanese Investigators concluded that the loss of engine power was caused by the separation of an engine compressor 3rd stage blade. The separated blade damaged the compressor case creating a hole on the case itself.

- 1) airfoil fracture initiating in a corrosion pit, which then progressed in high cycle fatigue until the blade separated in overload, or
- 2) blade tip rub caused by delamination of the case plastic lining due to corrosion underneath the vane outer band.

The probable cause of the corrosion of the compressor is the improper compressor maintenance during operation in a corrosive environment.

The compressor case damaged by the detached compressor blade

The accident reminds the need for the CAMO to review the environmental conditions according to the continuing airworthiness data released by manufacturers, and to adapt the aircraft maintenance programme properly. It also reminds the need for the maintenance personnel to strictly adhere to the instructions laid down into the aircraft maintenance programme, giving the right attention to all the instructions received without shortcutting. It reminds the owners about the proper qualification of the service provider. Don't stop to the approval certificate, go deeper (e.g. look at the training records, pretend personnel basic and recurrent training, look at competence assessment).
