Newsletter Human Factors recurrent training – Marzo 2015

Newsletter Human Factors recurrent training – March 2015

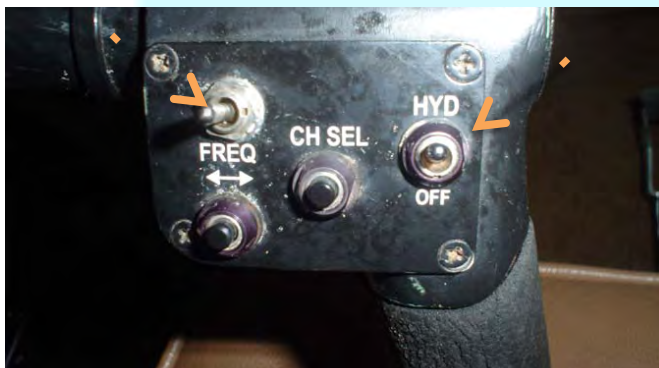
La fotografia mostra la configurazione trovata sull'elicottero ZS-RKW (fonte: rapporto d'inchiesta).

Si può facilmente dedurre che anche l'altro elicottero avesse una configurazione simile, se non la stessa.

Volendo attivare l'altoparlante, il pilota ha inavvertitamente selezionato HYDR in posizione off.

I due incidenti, a mio avviso, evidenziano il ruolo fondamentale della CAMO, intesa come responsabile dell'aeronavigabilità in senso lato, dimostrando l'importanza di una valutazione attenta delle modifiche che si vogliono apportare all'aeromobile.

Una valutazione attenta delle modifiche può evidenziare la possibilità di interferenza tra due differenti sistemi o incompatibilità di qualsiasi tipo, e, supponendo che la modifica sia approvata secondo norma, permettere quantomeno l'intrapresa delle azioni mitigatrici (ad esempio uno specifico addestramento del personale di volo).

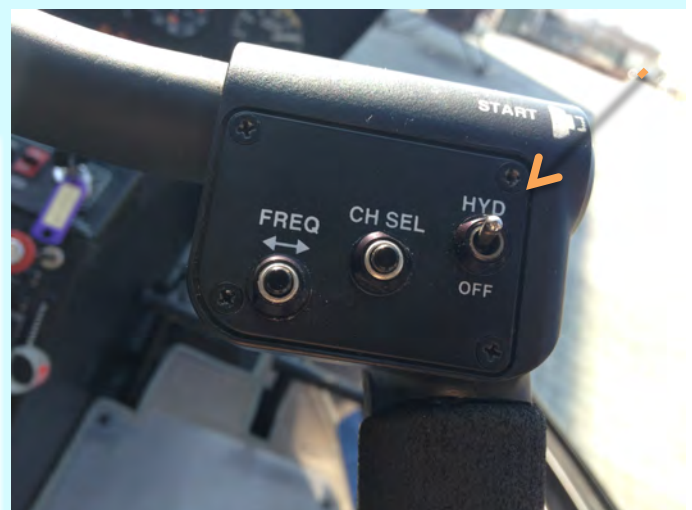
L'immagine mostra una configurazione differente, in questo caso quella originale proposta dal costruttore.

Notare che il controllo dell'altoparlante non è sul ciclico bensì sul pannello audio come mostrato sotto.

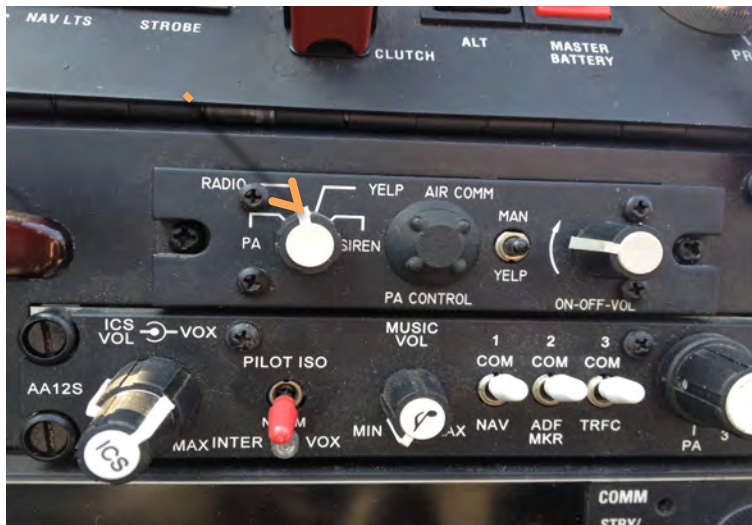
La centralina audio è posizionata sulla consolle.

L'attivazione dell'altoparlante non influisce con i comandi di volo o altri impianti.

Questa installazione è quella fornita dal costruttore dell'elicotero mentre la precedente non lo è.

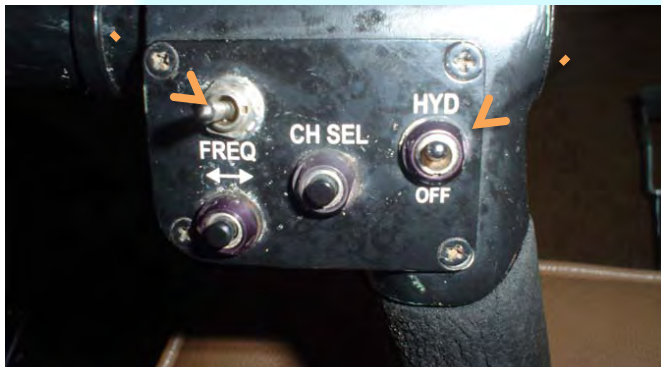
The image shows the configuration found on ZS-RKW (source: accident investigation). It is possible to assume that the other helicopter had a quite similar configuration. While trying to activate the speaker, the pilot inadvertently switched HYDR into off position.

In both accidents, a major role was played by the CAMO, to be intended as the responsible for the airworthiness, such demonstrating the importance of the proper assessment of any modification to be fitted into an aircraft.

A properly carried out assessment of the modification would certainly highlight the possibility of mis-controlling the system and, provided the approval of the modification, at least the establishment of mitigative actions (for example, specific training to flight crew).

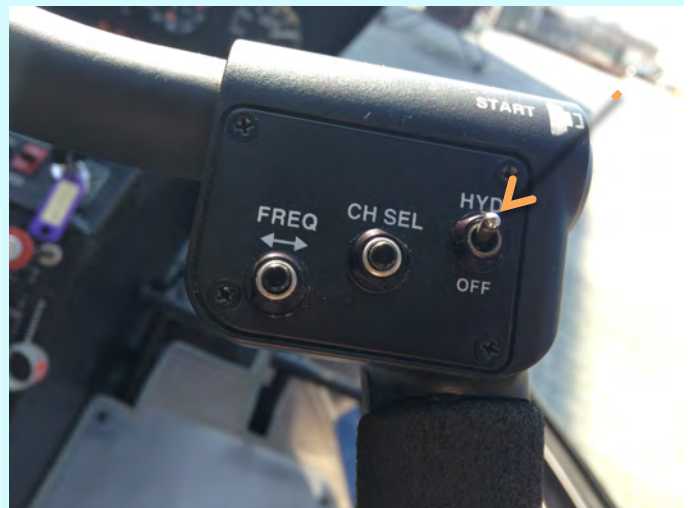
This image shows a different configuration, this time originally fitted by helicopter manufacturer.

Note that the speaker control is not positioned on the cyclic but is located on the audio control panel on the instrument console as shown below.

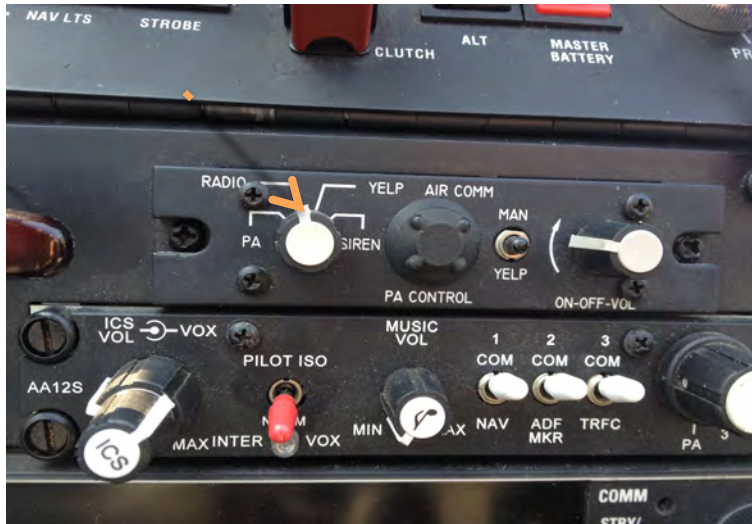
Audio control panel located on the instrument console.

Operations of the speaker selector does not interfere with any flight sensitive control like the hydraulic system.

This installation is the original offered by the helicopter manufacturer while the previously shown is not.
