Newsletter Human Factors recurrent training

Riporto di seguito il rapporto preliminare d'inchiesta relativo all'incidente avvenuto il 2 gennaio 2013 ad un EC130B4 in servizio HEMS negli Stati Uniti.

I'll inform you about the preliminary report for the accident occurred to an HEMS EC130B4 helicopter in the USA last January 2013.

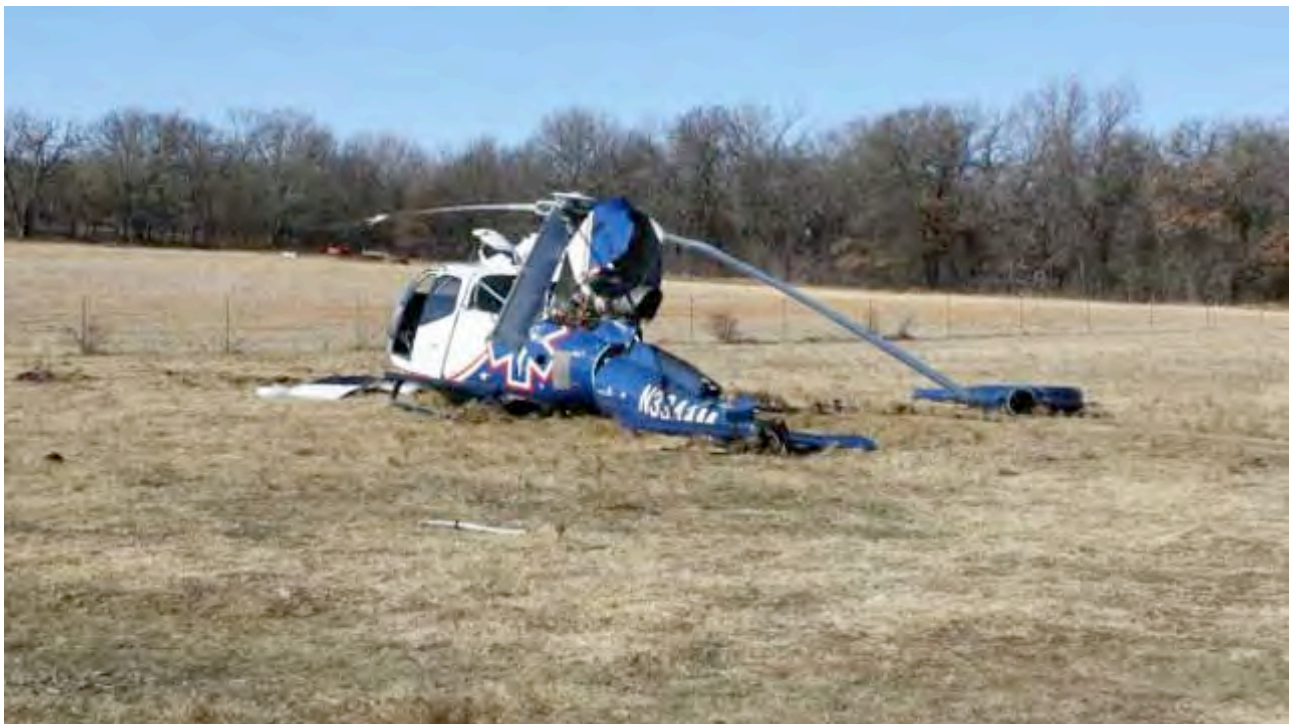
Il pilota ha riportato di aver sentito un suono come qualcosa che avesse colpito l'elicottero poco dopo la partenza mentre volava a circa 1.600 a 1.700 ft . Il motore ha quindi perso potenza e il pilota eseguiva un'autorotazione verso un terreno sottostante. Durante la manovra, l'evidenza di una recinzione non vista prima, comportava un atterraggio pesante al suolo.

Tutti quattro gli occupanti hanno riportato ferite serie nell'impatto col suolo.

L'investigazione sul motore Arriel 2 ha rivelato che quattro palette del compressore presentavano deformazioni significative sui loro bordi di entrata nella direzione opposta di rotazione normale, deformazioni coerenti con l'ingestione di corpi estranei.

Sulla base delle condizioni meteorologiche cui l'elicottero è stato esposto durante i tre giorni prima dell'incidente, è probabile che il ghiaccio formato nella presa d'aria del motore prima del volo sia stato ingestito dal motore danneggiand le pale del compressore .

- La perdita di potenza del motore a causa di ingestione di ghiaccio.

Fattore causale è stato la decisione del personale di manutenzione di applicare tardivamente le protezioni alla presa d'aria ed allo scarico del motore fino a dopo che il motore era stato esposto a temperature di congelamento e l'inadeguatezza dei controlli prevolo quotidiani, che non hanno di fatto riscontrato la formazione di ghiaccio nella presa d'aria, permettendone la rimozione.

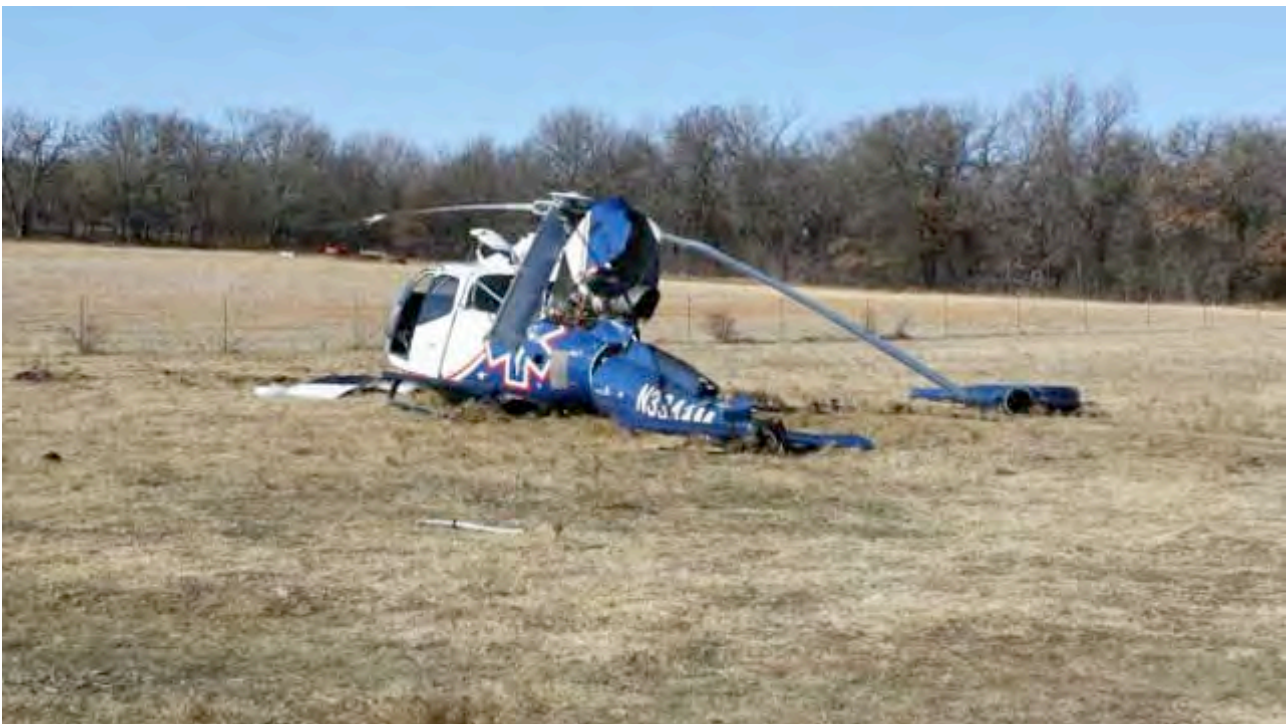
The pilot reported hearing a sound like something had struck the helicopter shortly after departure while about 1,600 to 1,700 feet mean sea level. The engine lost power, and the pilot performed an autorotation to a field. While maneuvering to land, he saw a barbed wire fence obstructing the intended landing area, so he maneuvered the helicopter to clear the fence. The helicopter subsequently cleared the fence and landed hard in a field.

Engine examination revealed that the four axial compressor blades exhibited significant deformation on the outboard tips of their leading edges in the direction opposite of normal rotation consistent with the ingestion of soft body foreign object debris, such as ice. A subsequent engine run did not detect any preimpact anomalies that would have precluded normal operation. For 3 days before the accident flight, the helicopter was parked outside without its engine cover installed and was exposed to light drizzle, rain, mist, and fog. The

engine inlet cover was installed the day before the accident at an unknown time. The helicopter remained outside and exposed to freezing temperatures throughout the night until 2 hours before the flight. Although the helicopter was maintained in a ready status on the helipad and maintenance personnel performed daily preflight/airworthiness checks, the inlet to the first-stage of the axial compressor was not inspected to ensure that it was free of ice in accordance with the Aircraft Maintenance Manual. Based on the weather conditions that the helicopter was exposed to during the 3 days before the accident, it is likely that ice formed in the engine air inlet before the flight and that, when the pilot increased the engine power during takeoff, the accumulated ice separated from the inlet and was ingested by the engine and damaged the compressor blades.

- The loss of engine power due to ice ingestion.

Contributing to the accident was maintenance personnel's delayed decision to install the helicopter's engine inlet cover until after the engine had been exposed to moisture and freezing temperatures and their inadequate daily preflight/airworthiness checks, which did not detect the ice formation.
