Newsletter Human Factors recurrent training – April 2016

A B206B3 helicopter was hovering at low altitude carrying out an aerial work mission (jet washing high voltage power line insulators) in Taiwan when the engine lost power. The pilot managed to make a forced landing. The aircraft was substantially damaged and both the pilot and mission operator survived with minor injuries only.

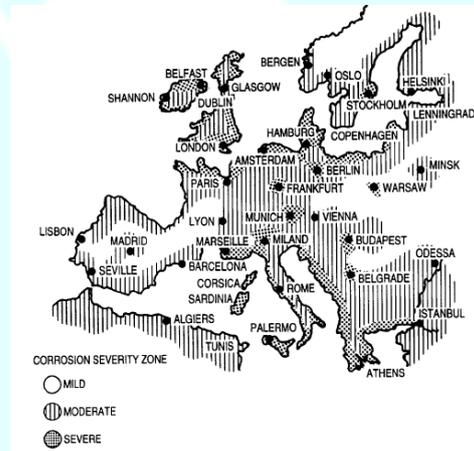
Extract from CSL-1135: Europe and Asia Minor corrosion severity map

RR250-C20 CSL-1135 published by Rolls-Royce contains instructions how to carry out periodical compressor rinse and classifies the world zones with reference to corrosion severity.

It is very interesting to note that many areas are defined as corrosive by Rolls-Royce, requiring the proper maintenance to be carried out, even if those areas are far from coastline (e.g. Northern Italy, Munich etc.).

The accident reminds the need for the CAMO to review the environmental conditions according to the continuing airworthiness data released by manufacturers, and to adapt the aircraft maintenance programme properly. It also reminds the need for the maintenance personnel to strictly adhere to the instructions laid down into the aircraft maintenance programme, giving the right attention to all the instructions received without shortcutting. It reminds the owners about the proper qualification of the service provider. Don't stop to the approval certificate, go deeper (e.g. look at the training records, pretend personnel basic and recurrent training, look at competence assessment).
